PERATION

GREENHOUSE

SCIENTIFIC DIRECTOR'S REPORT

ANNEX 3.2 U. S. NAVY STRUCTURES

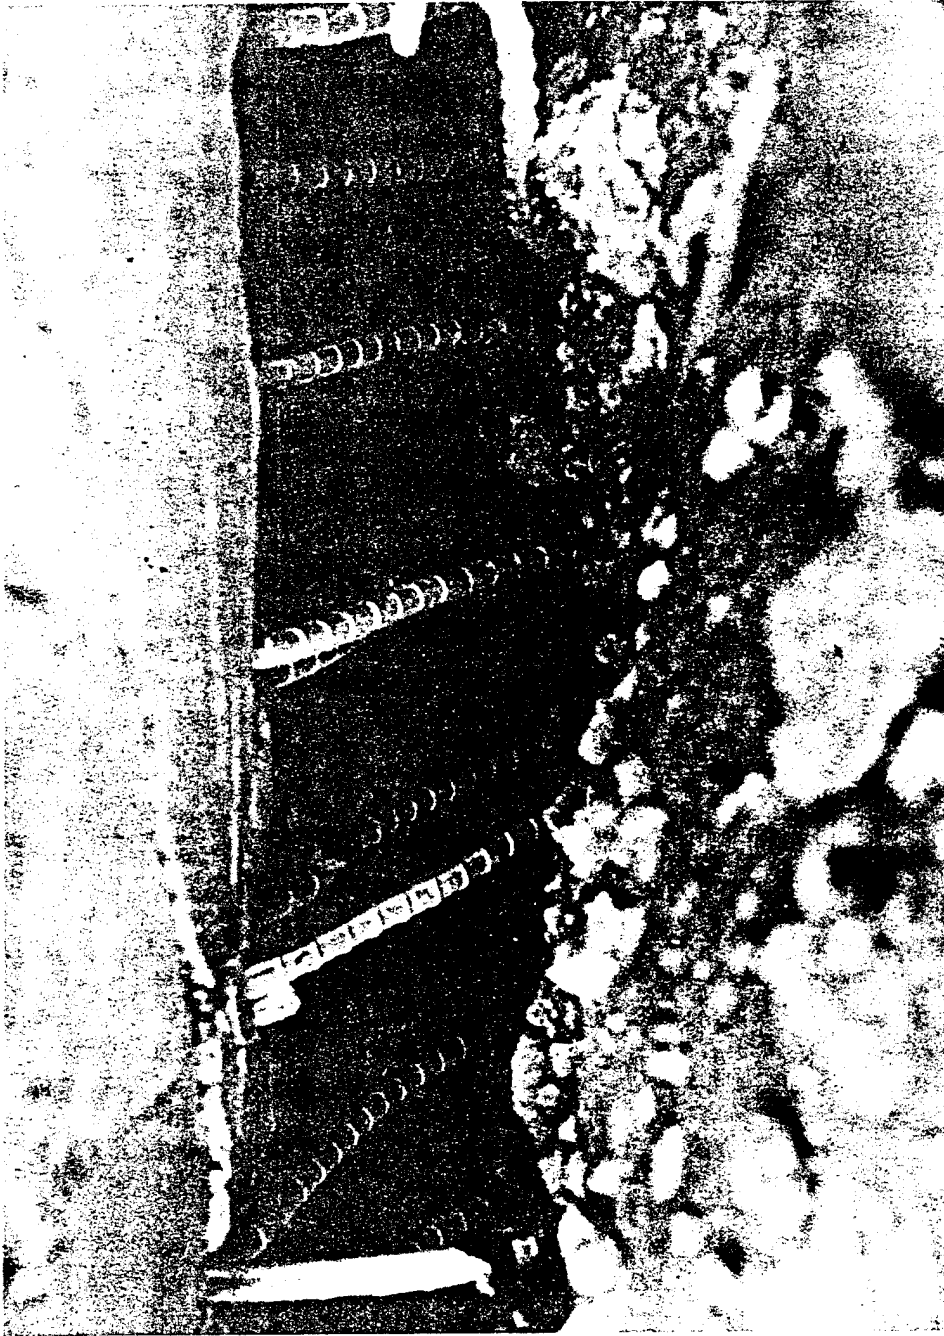
Fig. L.32 Close-up of Separation Between Roof Slab and Front Wall 6 ft from Right Corner, Structure 3.2.1a

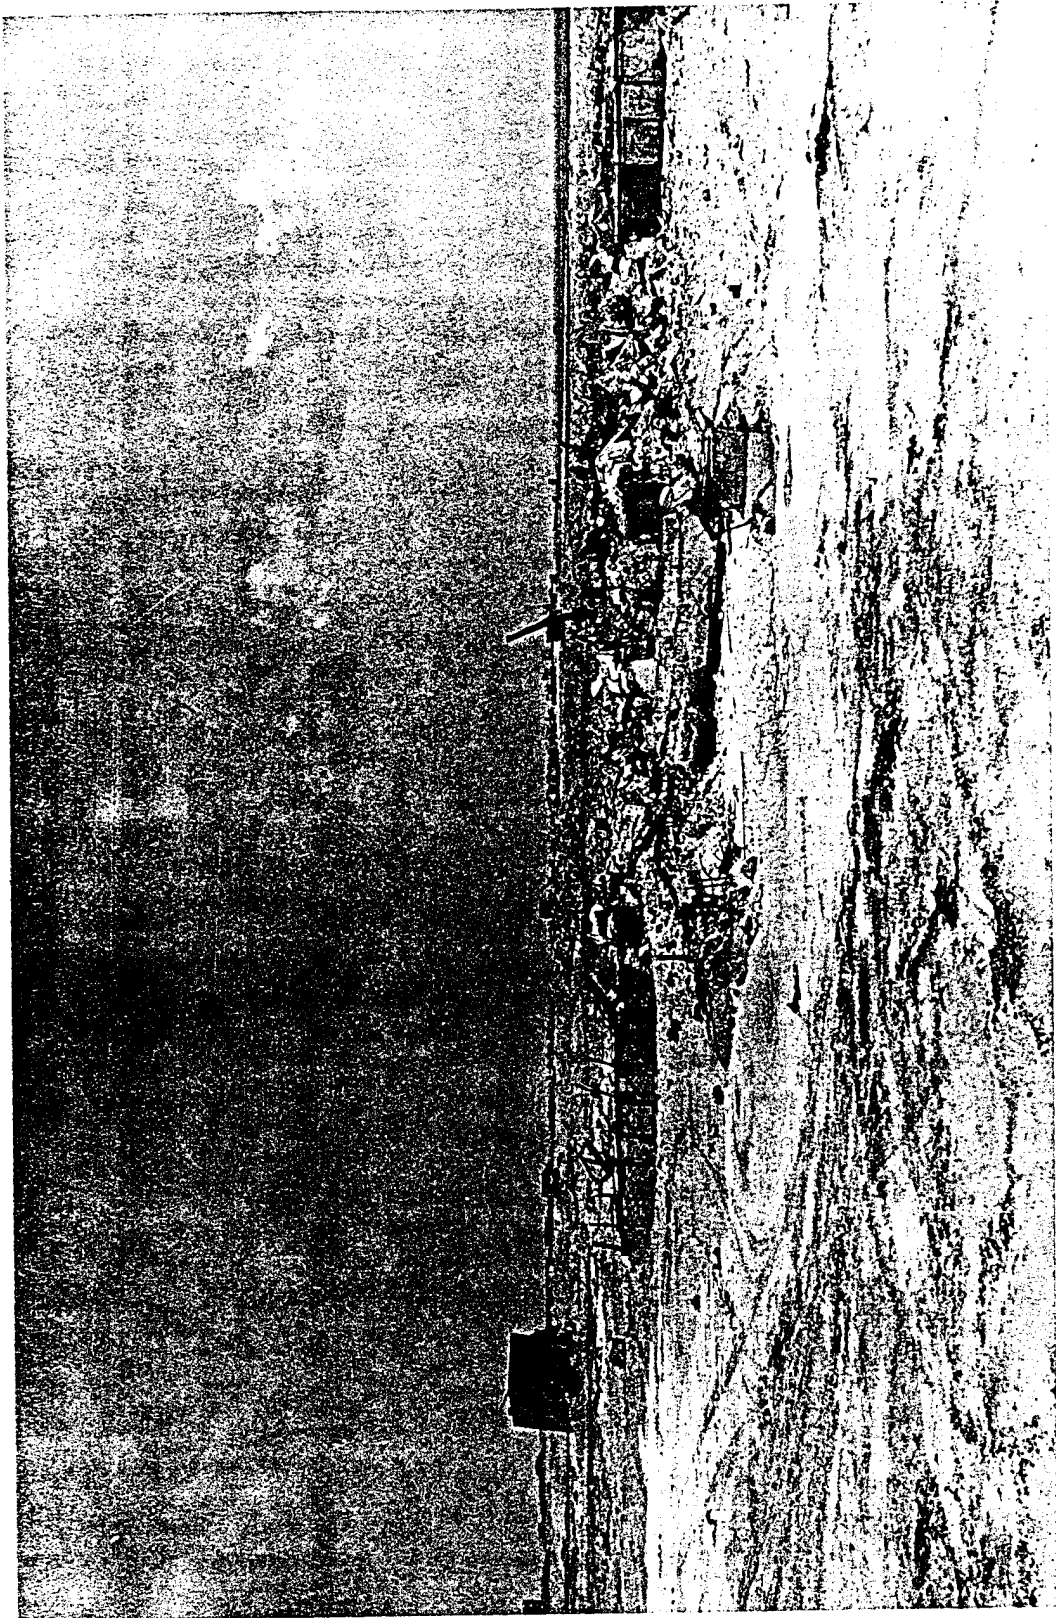
Fig. L.35 General View from Front, Structure 3.2.1b

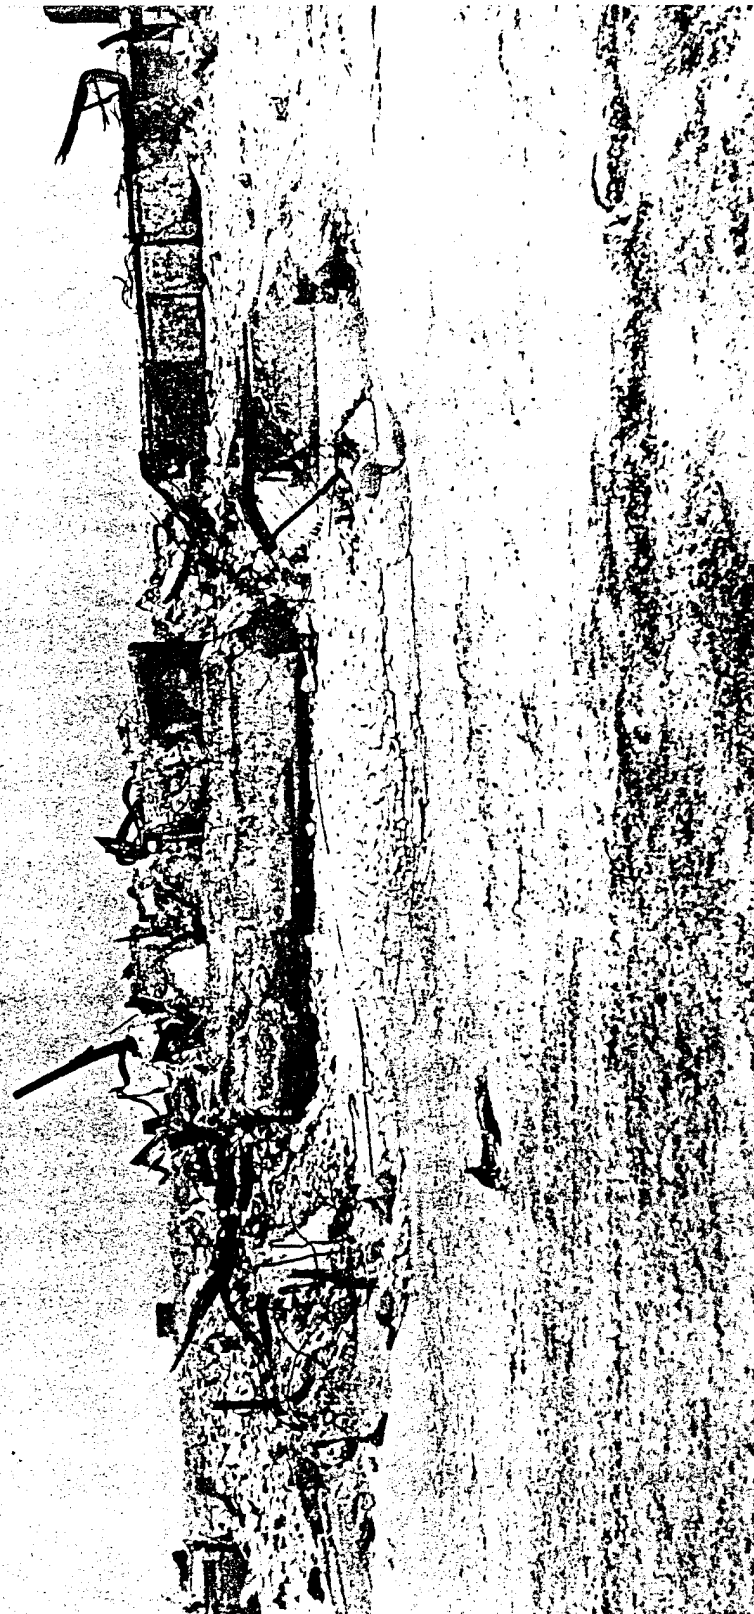
Fig. L.36 Front Bearing Wall Pushed to Rear, Structure 3.2.1b

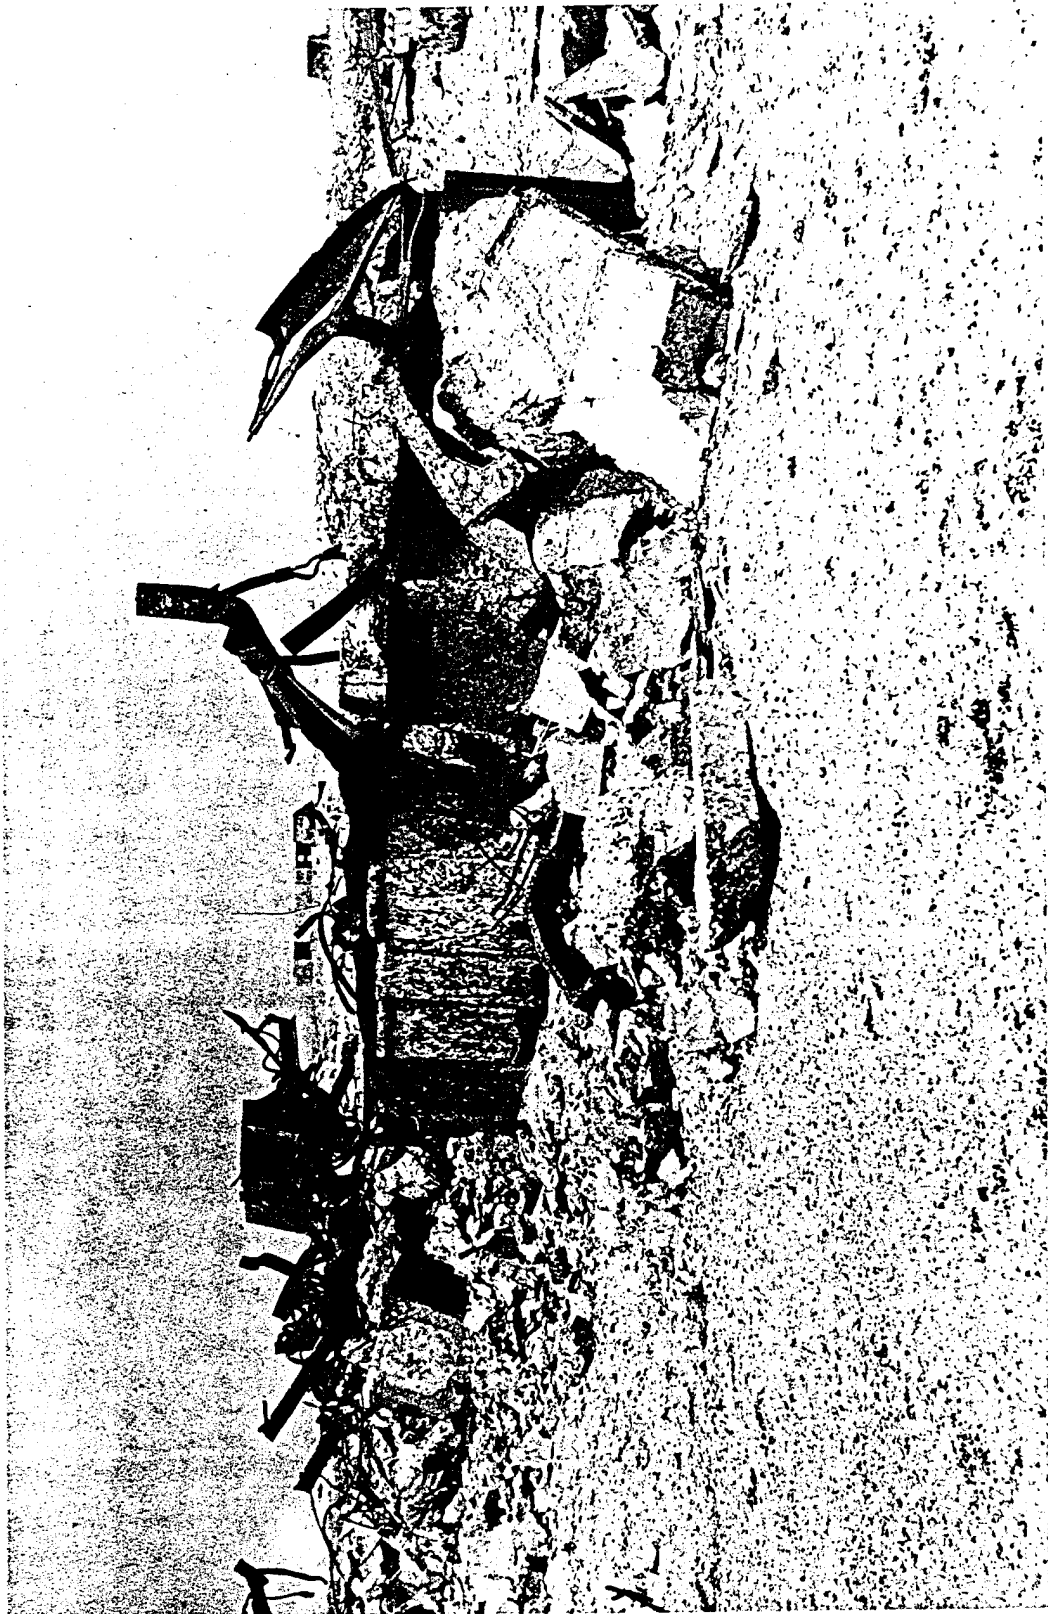
Fig. L.39 Filled Cells from Right Edge of Slab, Structure 3.2.1b. Note twisted steel trusses in background.

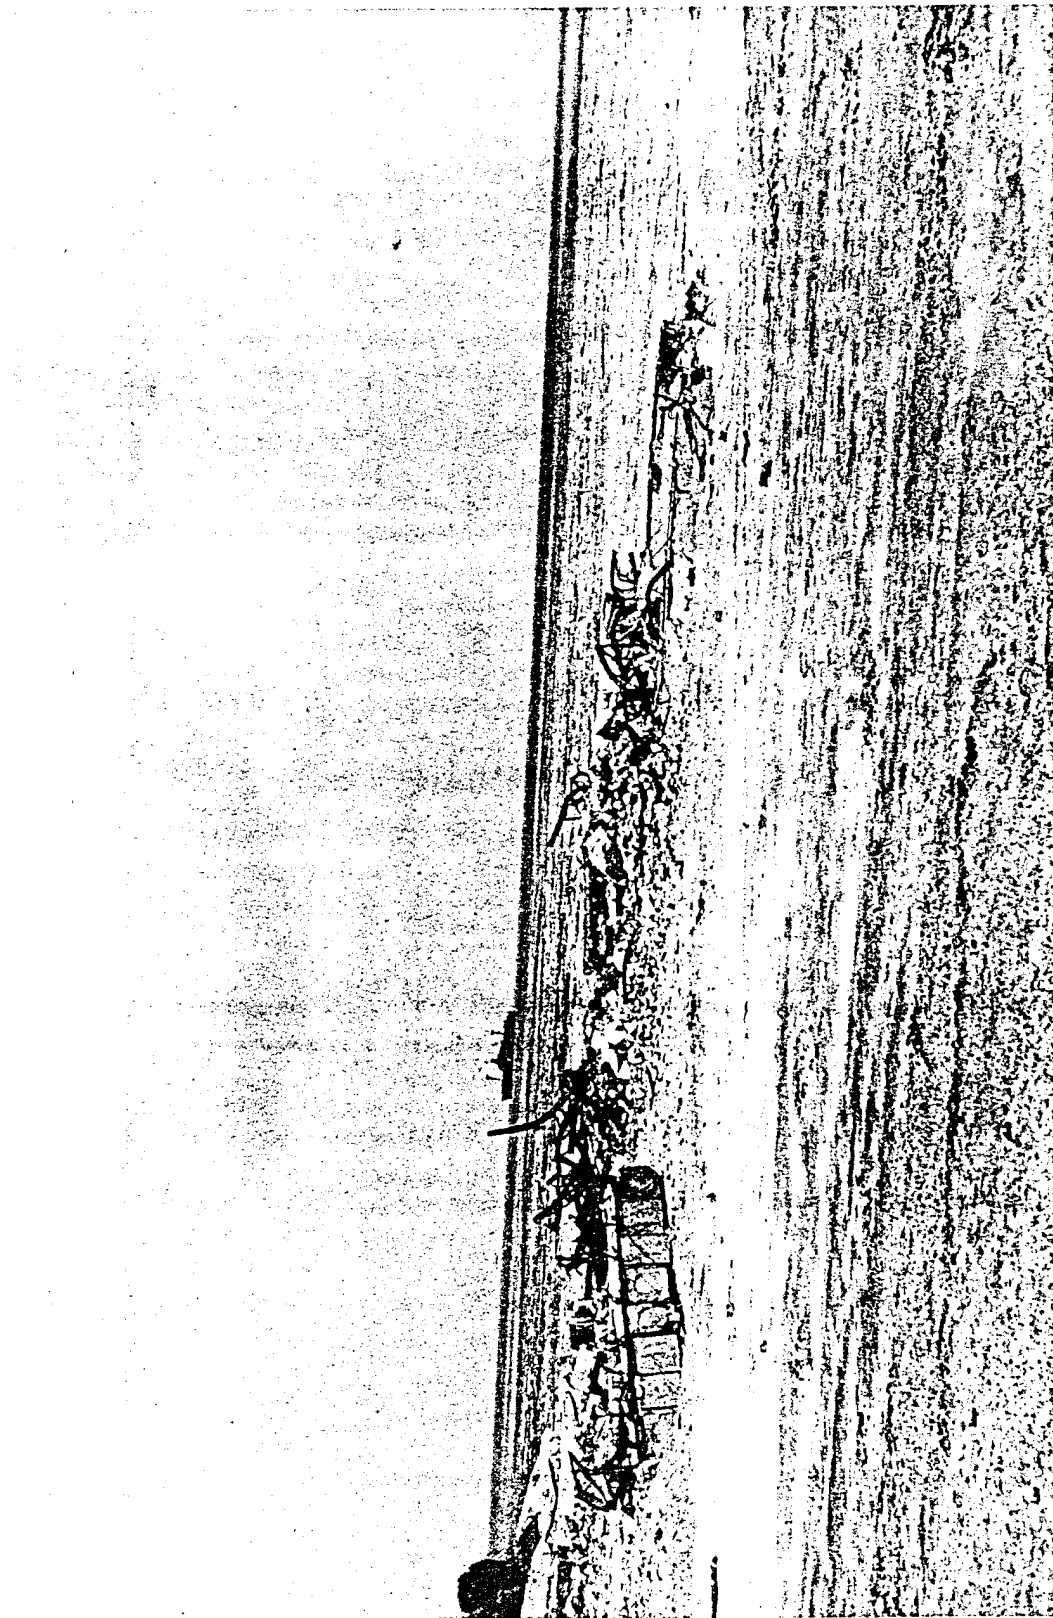
Fig. L.40 Rubble at Left, Structure 3.2.1b

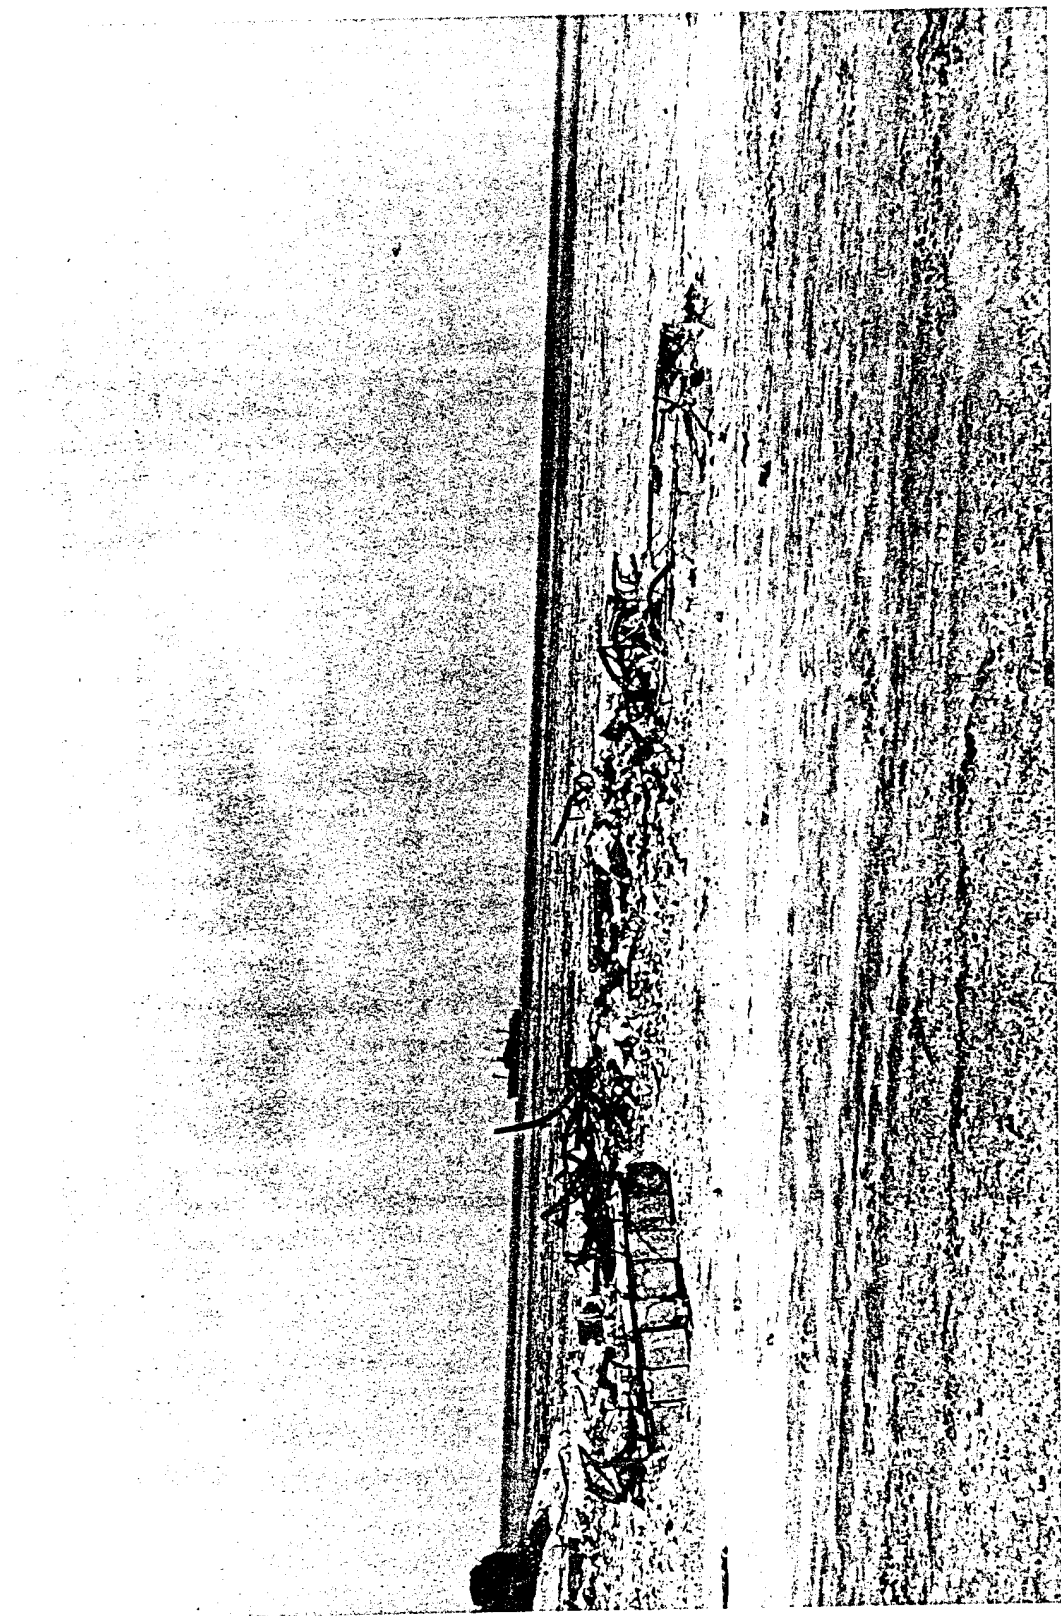
Fig. L.40 Rubble at Left, Structure 3.2.1b

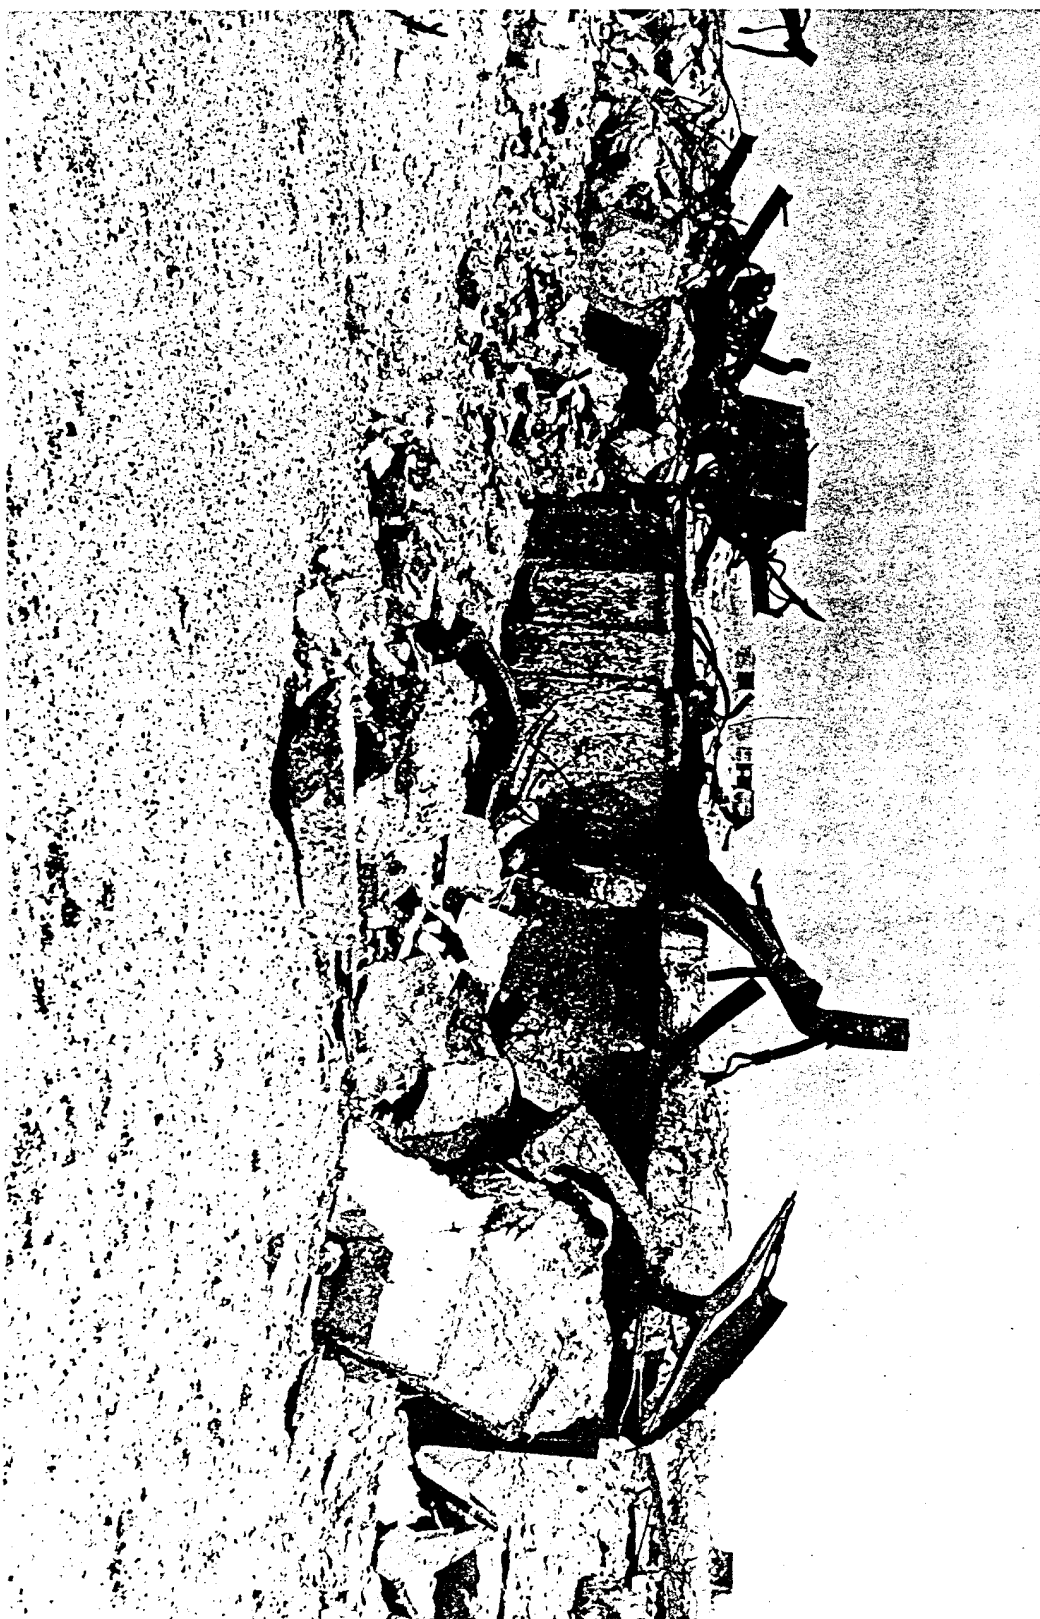
Fig. 1.39 Filled Cells from Right Edge of Slab, Structure 3.2.1b. Note twisted steel trusses in background.

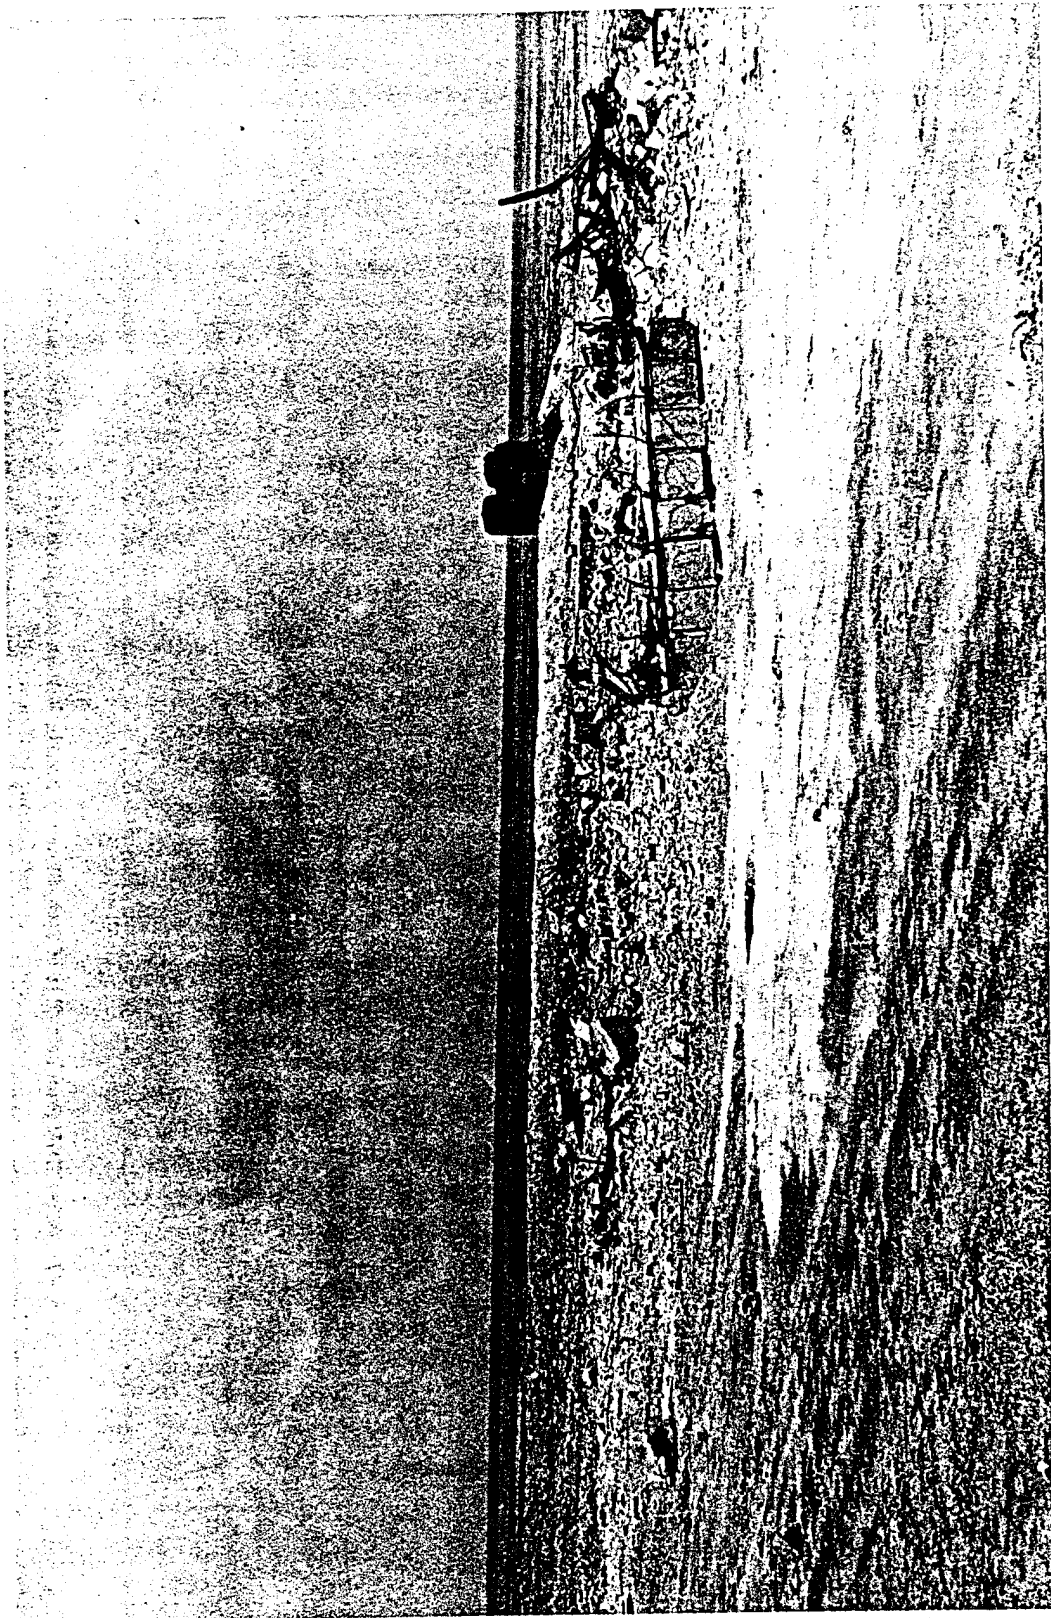
Fig. L.41 Rubble at Left Rear, Structure 3.2.1b

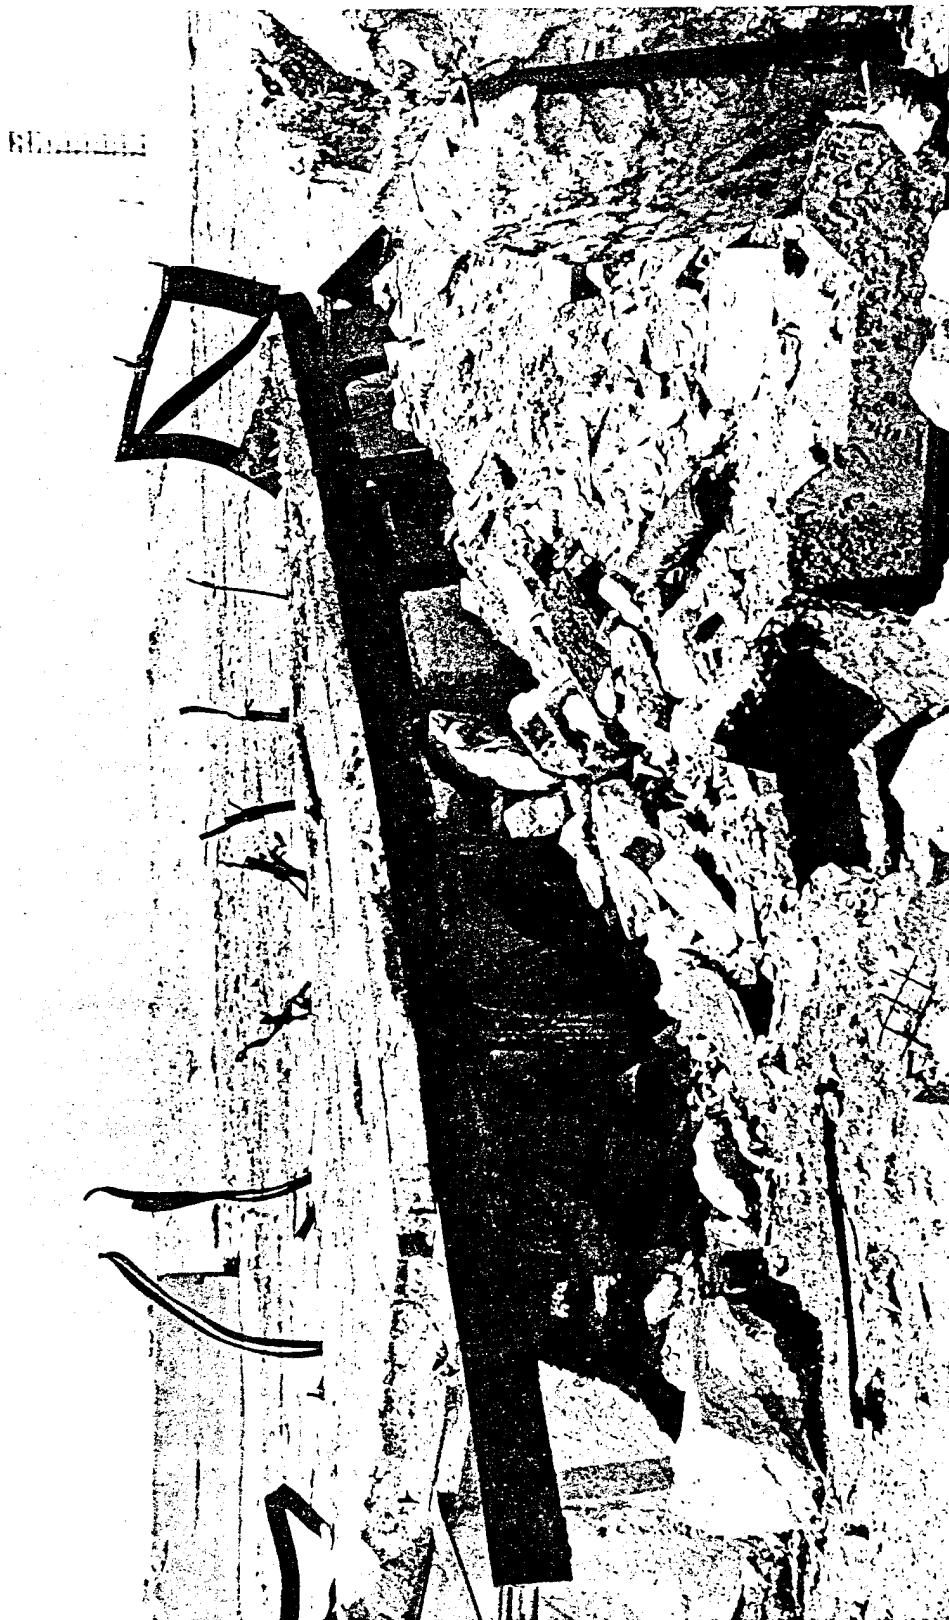
Fig. L.42 Filled Cells from Left Edge of Slab, Structure 3.2.1b. Bottom steel plate has weld failures where separation from left bearing wall occurred.

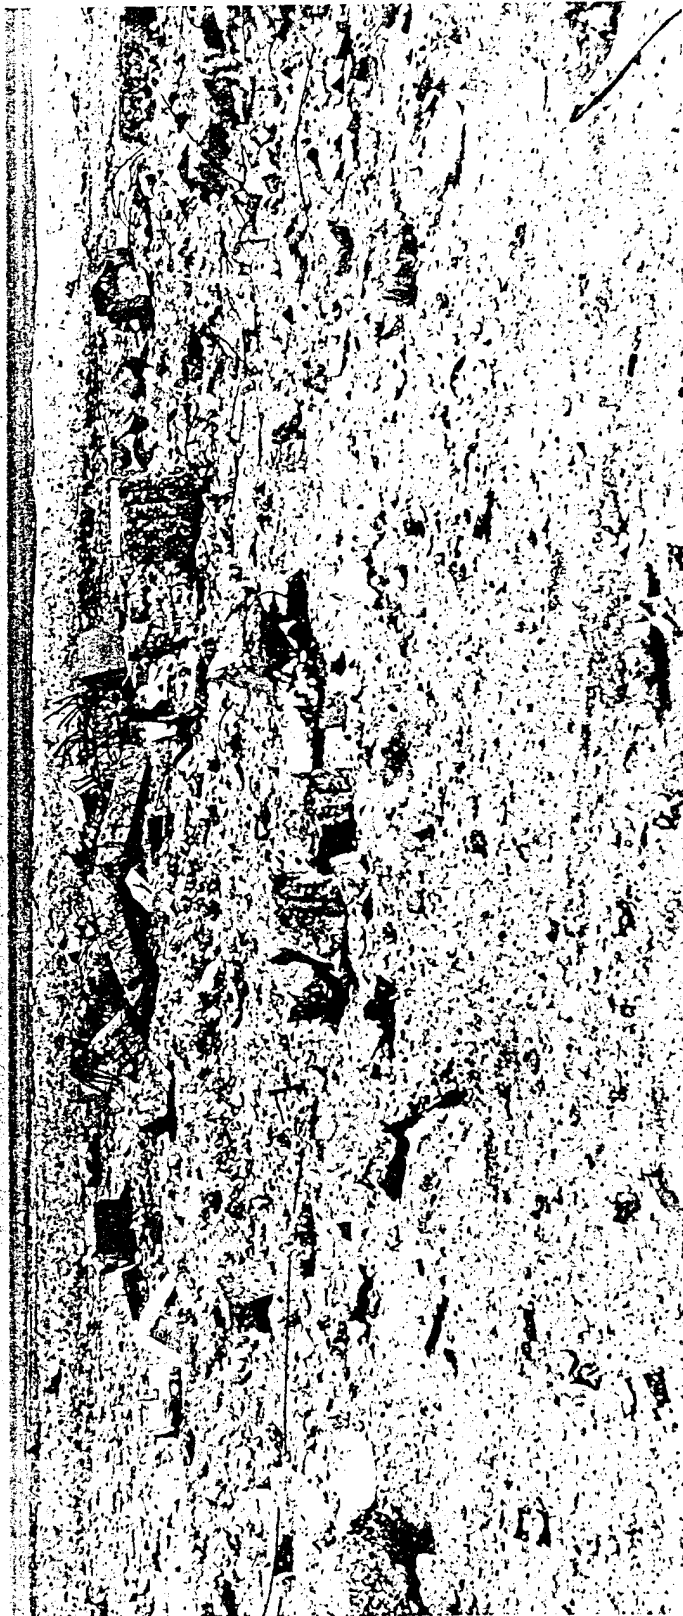
Fig. L.44 Debris at Rear of Structure, 3.2.1b. Top slab in background.

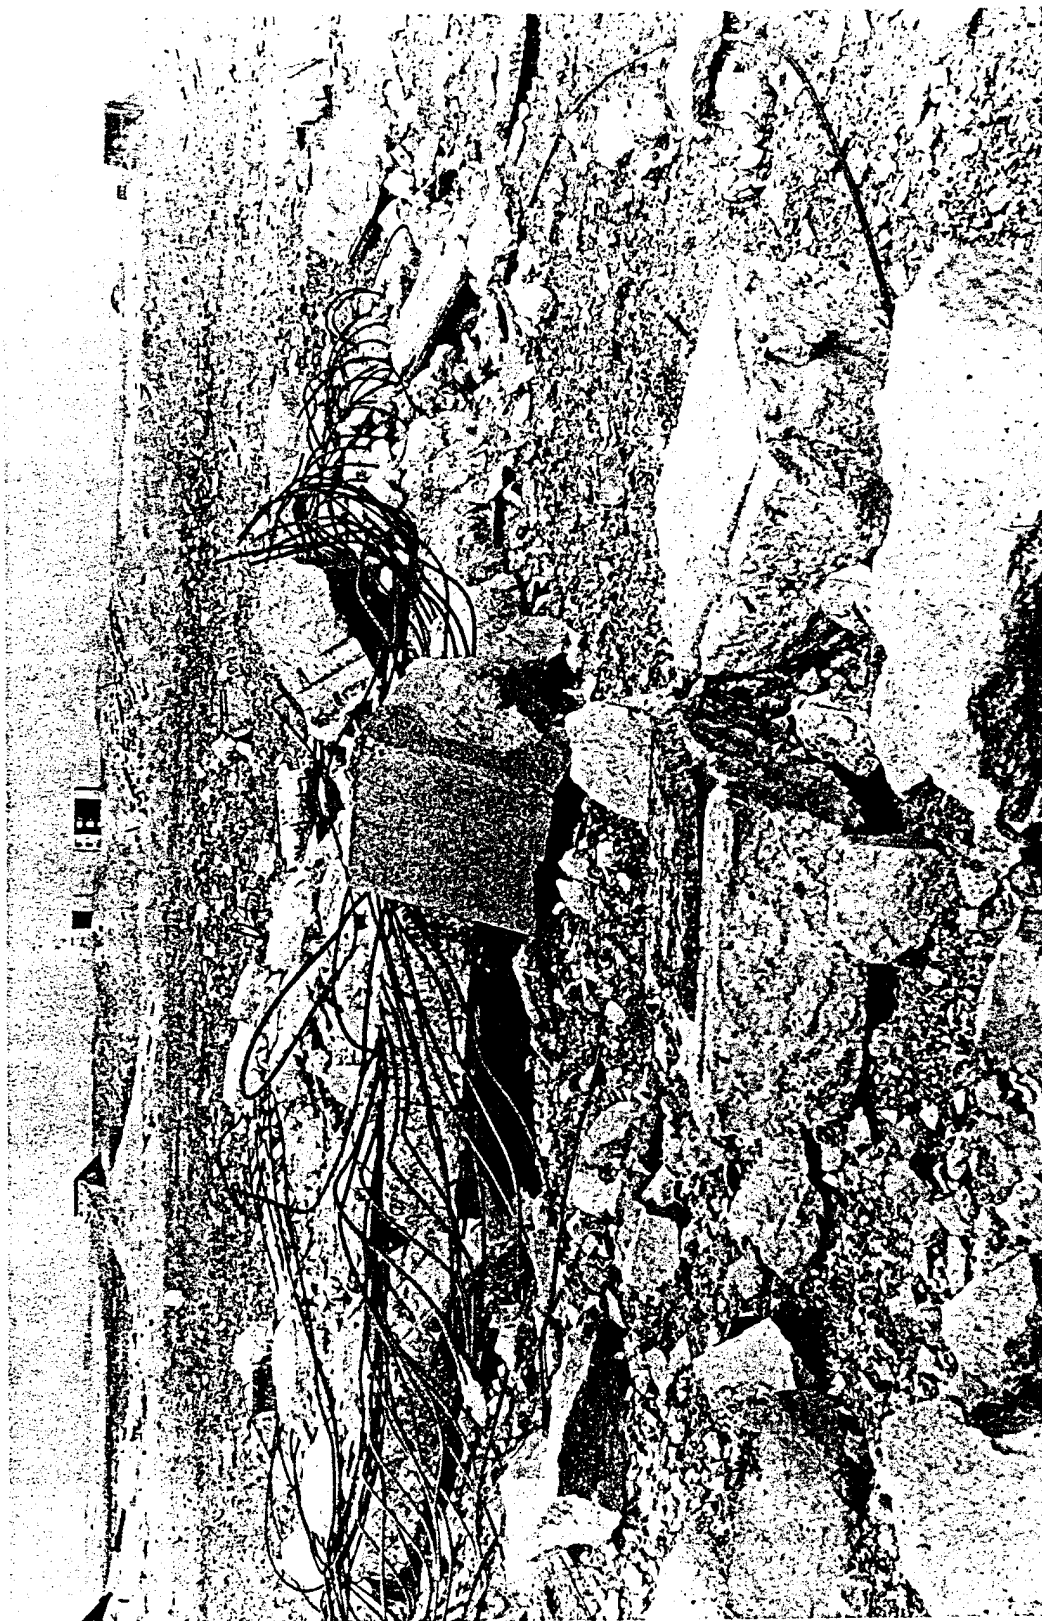
Fig. L.45 Close-up of Top Slab 150 ft behind Structure, 3.2.1b

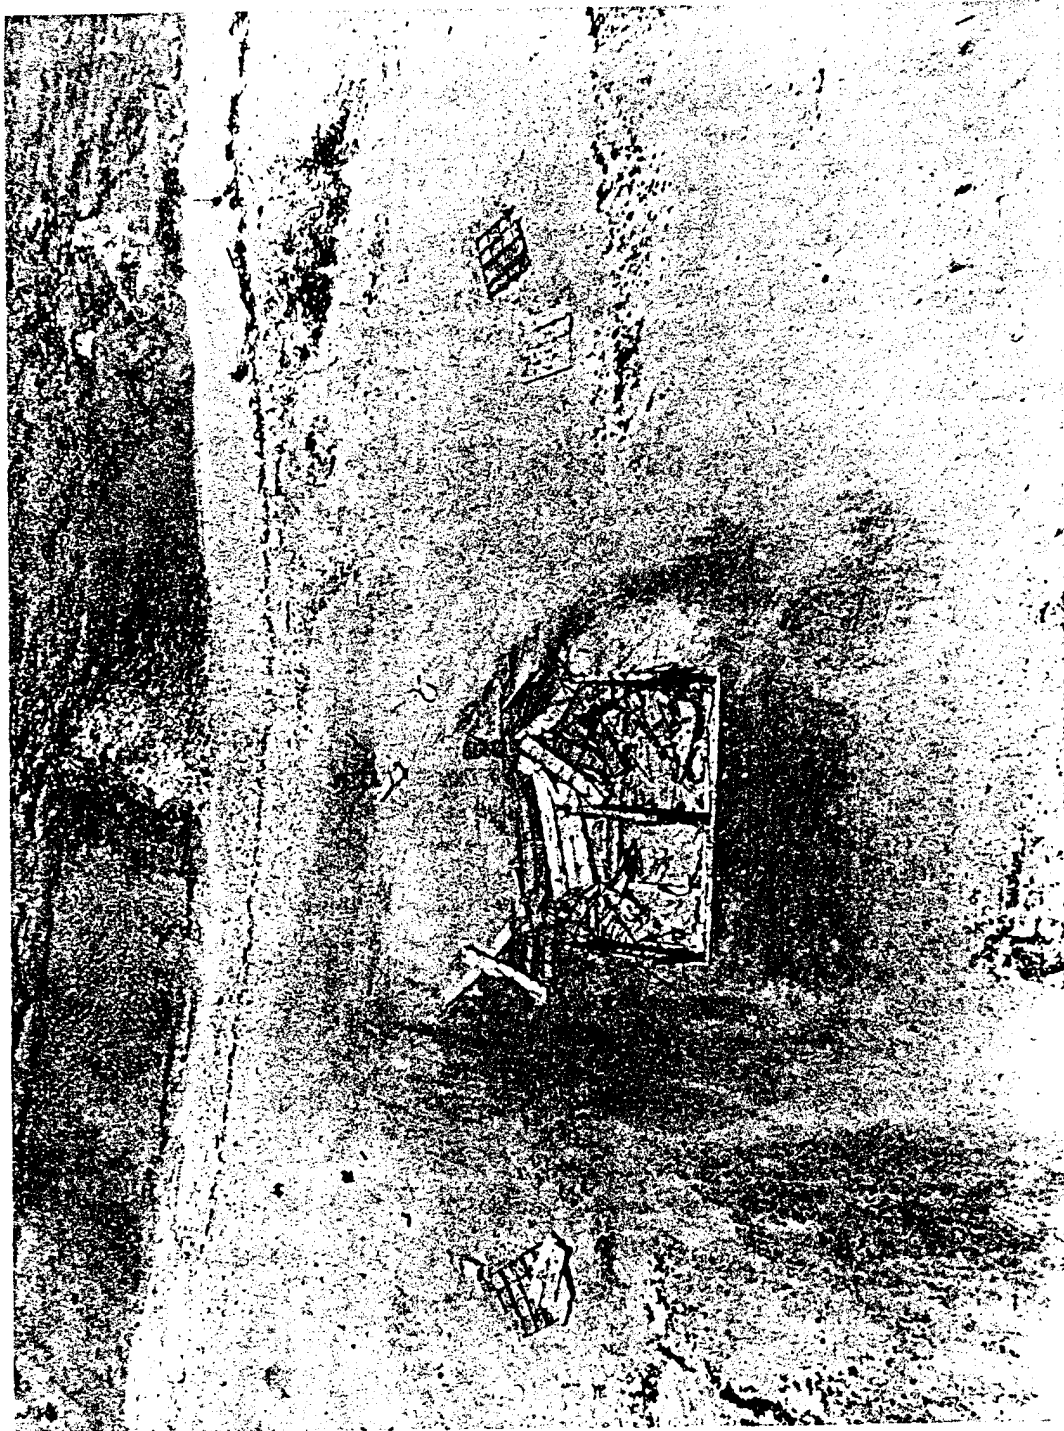
Fig. L.47 Postshot Aerial View, Structure 3.2.2a

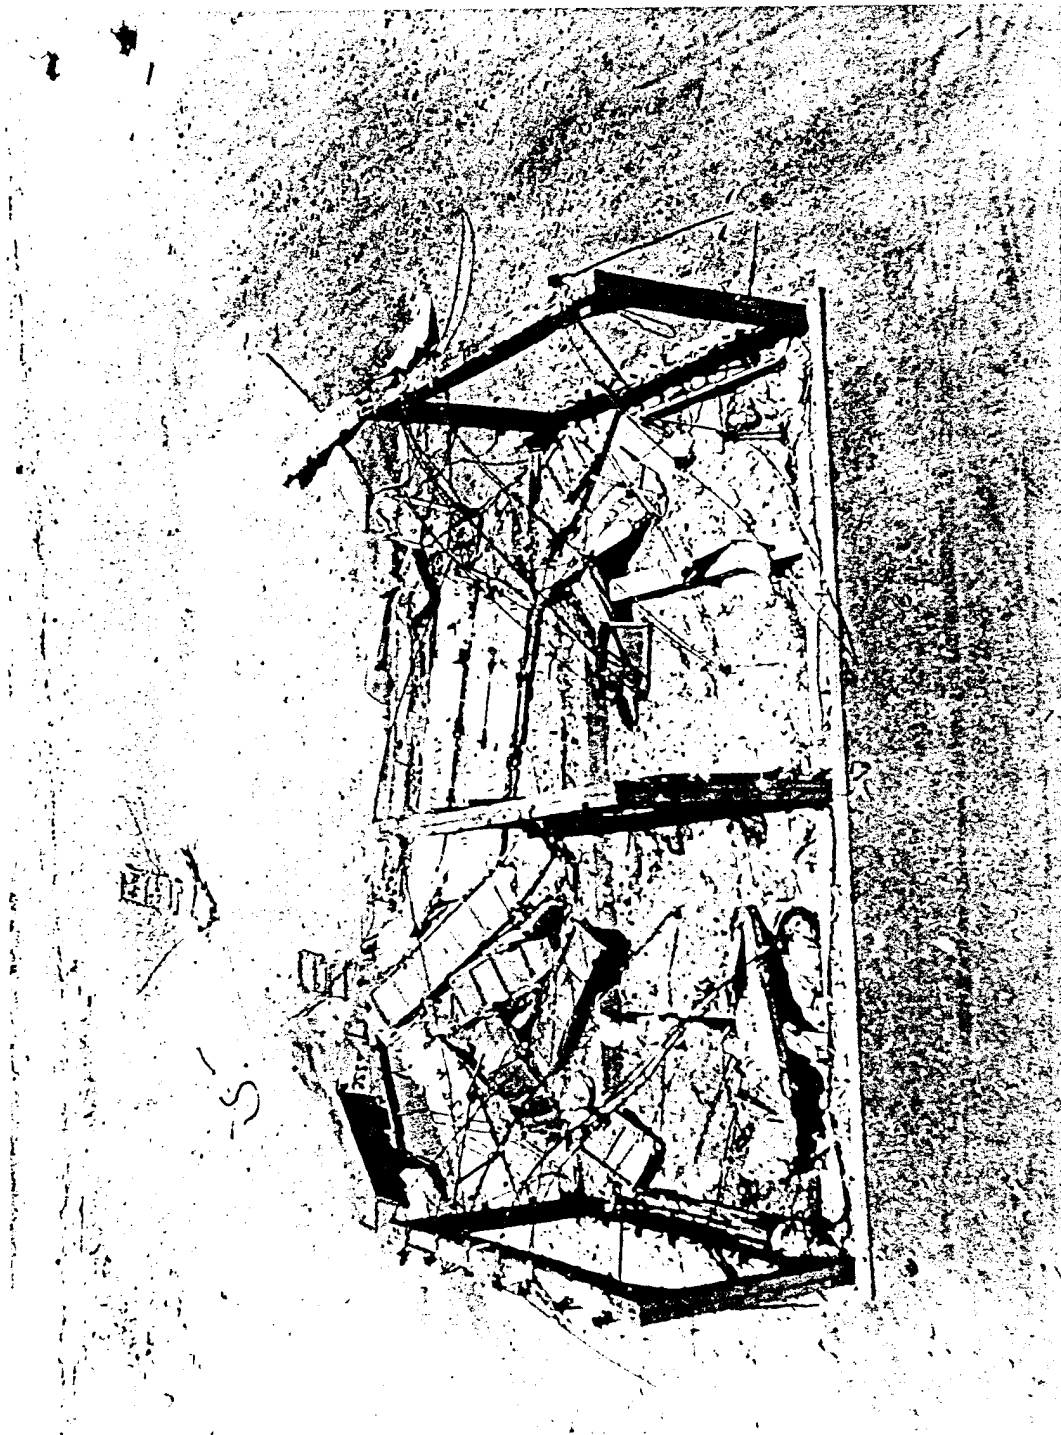
Fig. L.48 Close-up Aerial View from Front, Structure 3.2.2a

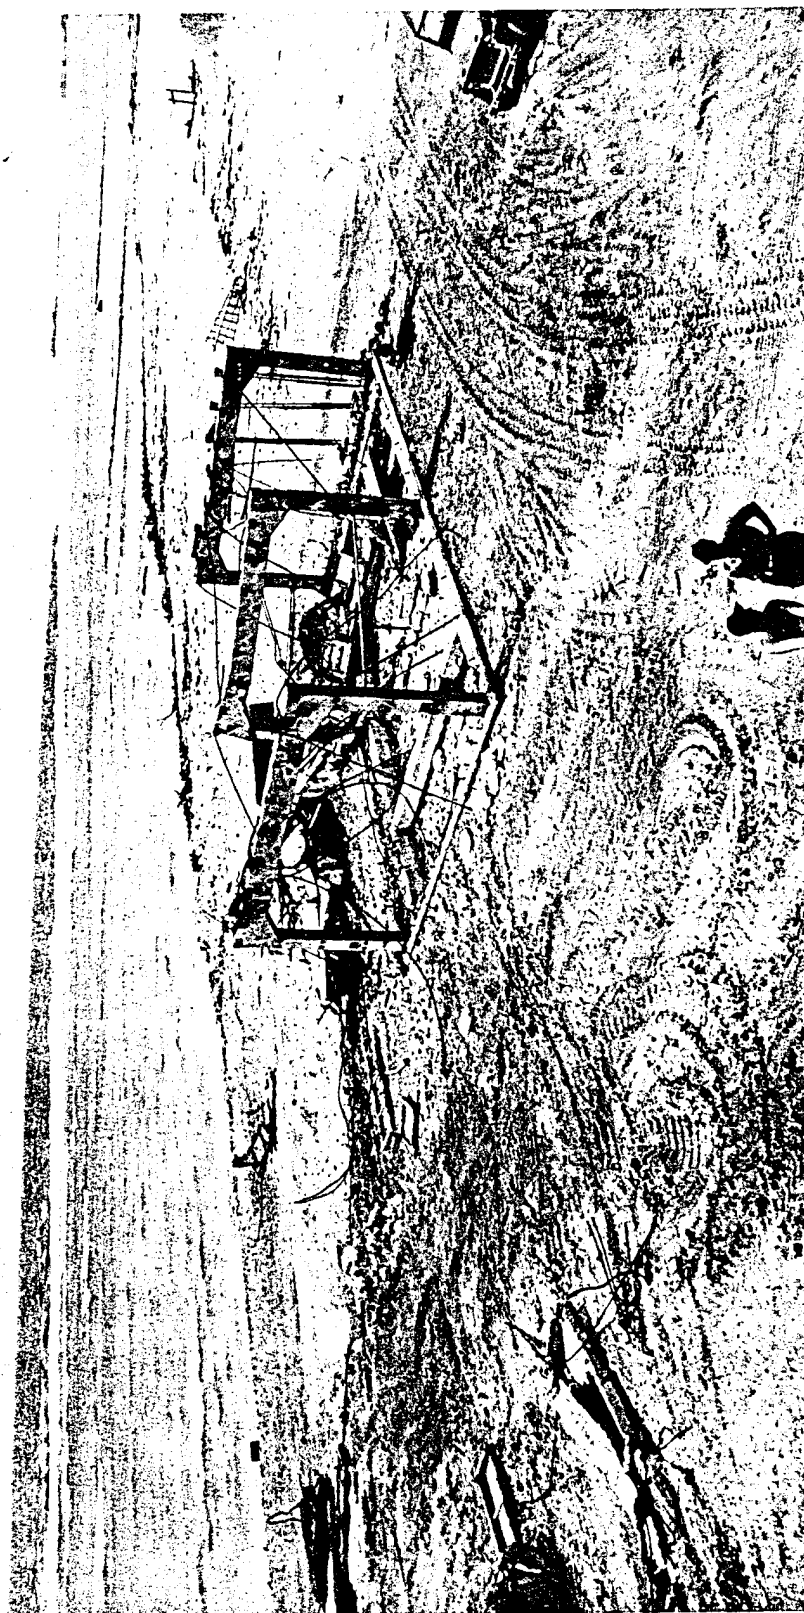
Fig. L.49 View from Left Front, Structure 3.2.2a

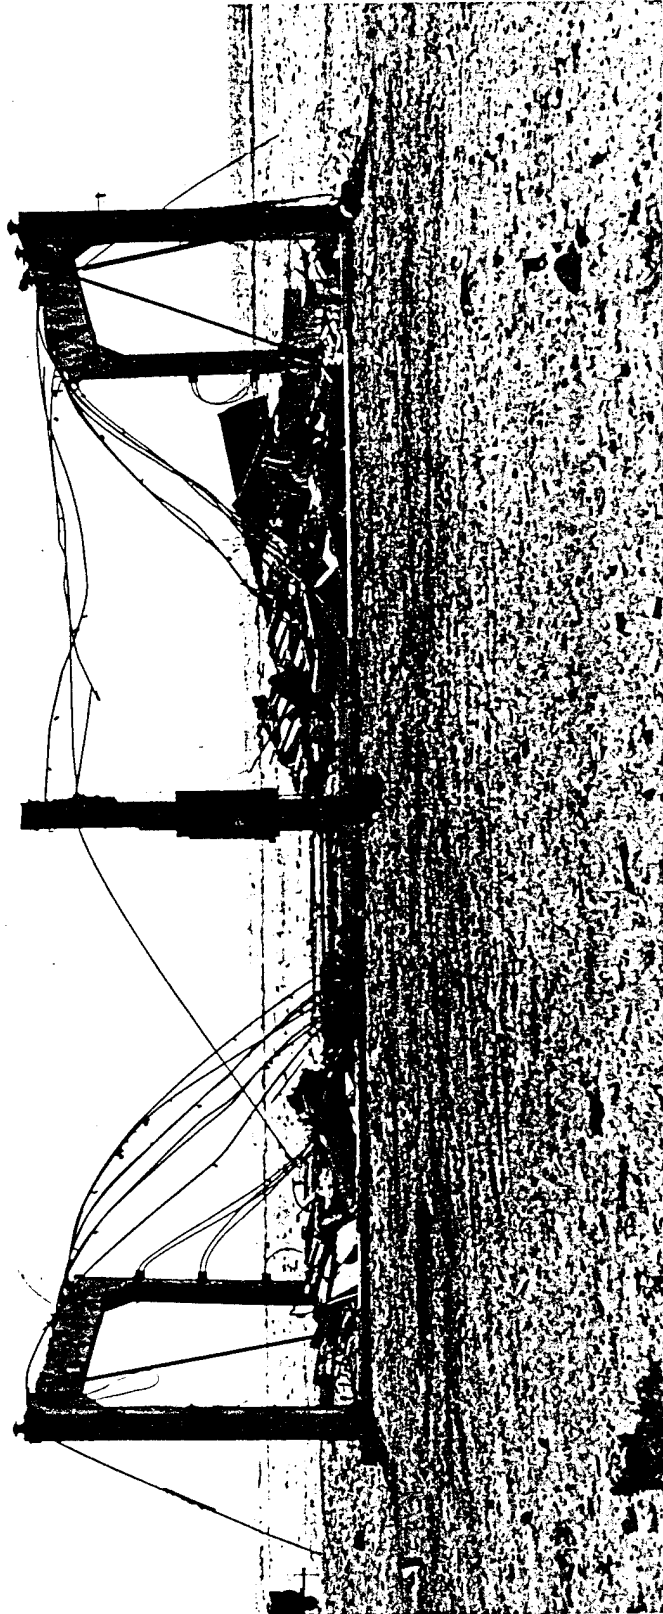
Fig. L.50 Front View, Structure 3.2.2a
